**BOEING AIRPLANE COMPANY**  
**WICHITA 1, KANSAS**

DOCUMENT NO. D3-2780 DATE 1-13-60  
MODEL All CONTRACT NO. \_\_\_\_\_  
TITLE SUMMARY OF TESTING: BMS 10-39 FUEL AND MOISTURE  
RESISTANT FINISH FOR FUEL TANKS  
ISSUE NO. \_\_\_\_\_ TO \_\_\_\_\_ DATE \_\_\_\_\_  
SHORT TITLE \_\_\_\_\_  
(FOR CLASSIFIED DATA)

**D3-2398, LABORATORY INVESTIGATIONS OF  
CORROSION PROTECTION IN B-52G INTEGRAL  
FUEL TANKS**

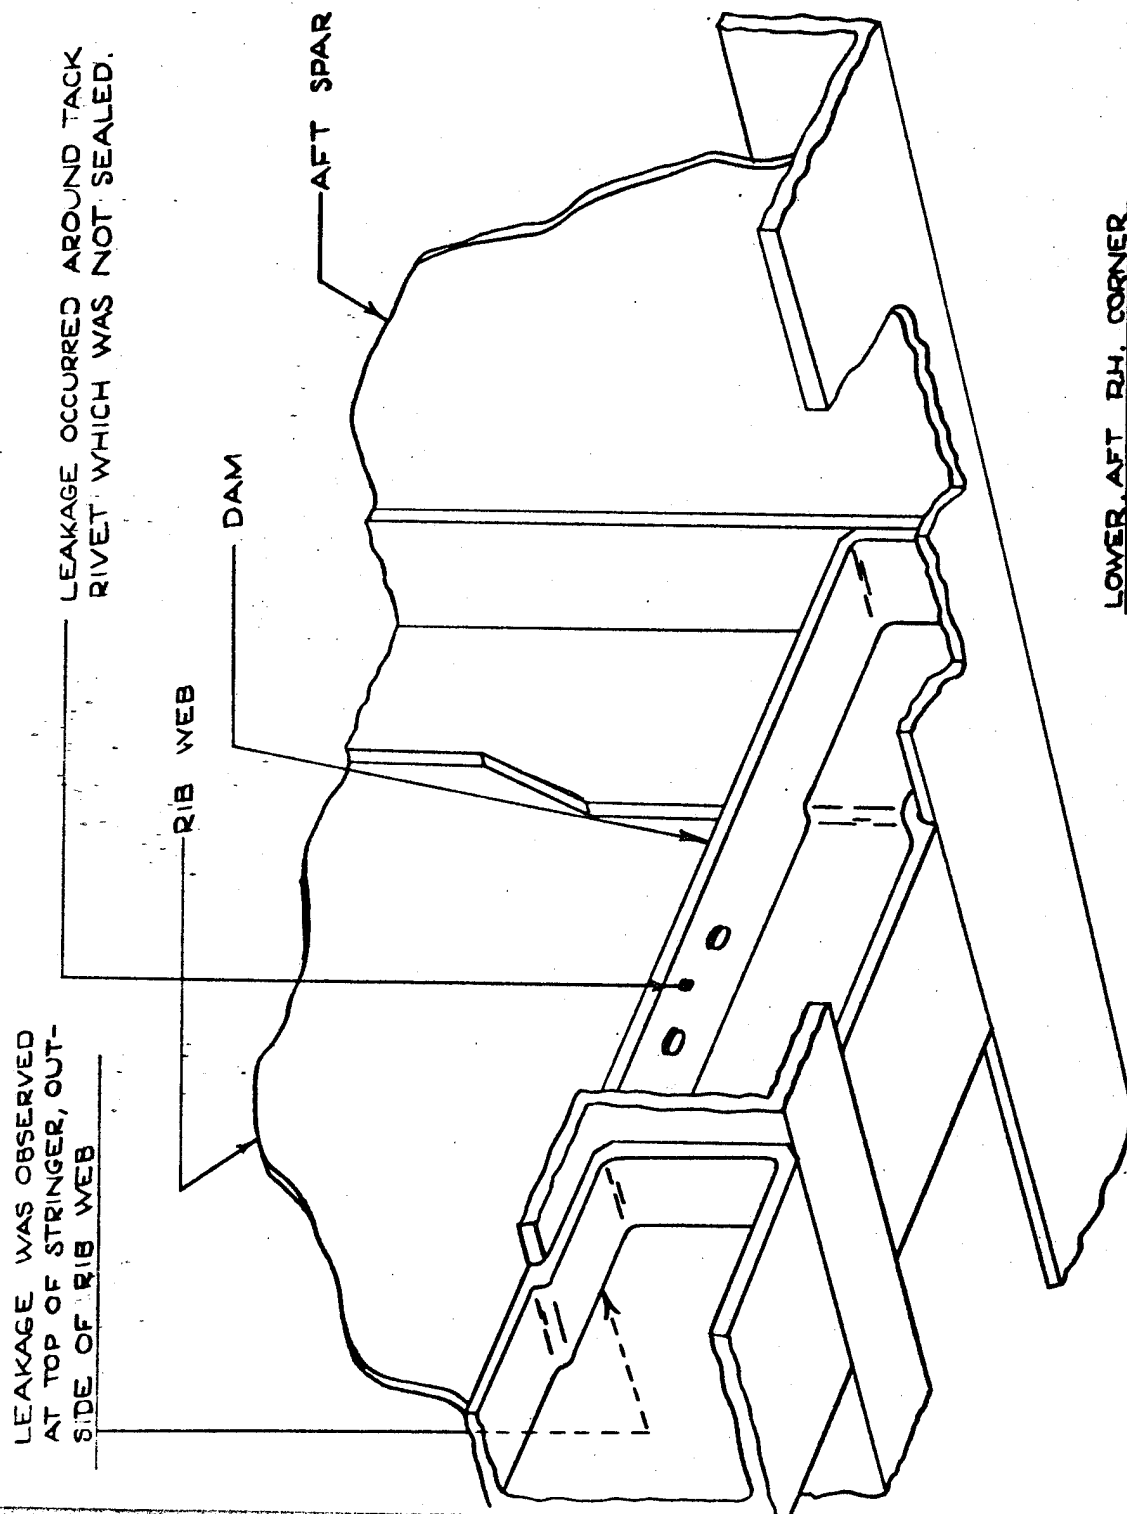
ILLUSTRATION NO. 4  
NACA RIVET LEAK

CUBE NO.	NO. OF LEAKS	LOCATION OF LEAK ON OUTSIDE STRUCTURE	LEAK DETECTION METHOD	INSIDE SOURCE OF LEAK	ACTION TAKEN
1	4	R. H. side, lower R. H. corner between lower rib chord and rib web	Ammonia - Leak Detection Paint Ammonia - Phenolphthalein Halogen Detector	Huck bolt not sealed	All huck bolts were sealed
2	1	R. H. side, between top of "Z" stiffener and lower rib chord	Ammonia - Phenolphthalein Halogen Detector Dyed Fuel	Tack rivet on top lower (see illust. No. 1)	Tack rivet sealed
	1	L. H. side, between top of "Z" stiffener and lower rib chord	Ammonia - Phenolphthalein Halogen Detector Dyed Fuel	AN bolt leaked (see illust No.2)	AN bolt resealed (bolt out of direct line of vision and difficult to seal) Fillet applied over crack in dam
	1	L. H. side, between bottom of upper center fuel dam and rib chord	Halogen Detector	Small crack in fuel dam (see illust. No. 3)	
	1	L. H. side, between bottom of upper fuel dam and rib chord (second dam from RF)	Halogen Detector	NACA rivet in upper fuel dam leaked (see illust No. 4)	Rivet was sealed
